## Tests of fire suppression effectiveness of damaged water mist systems

DRDC-RDDC-2014-C70  
May 2014

### SP Technical Research Institute of Sweden

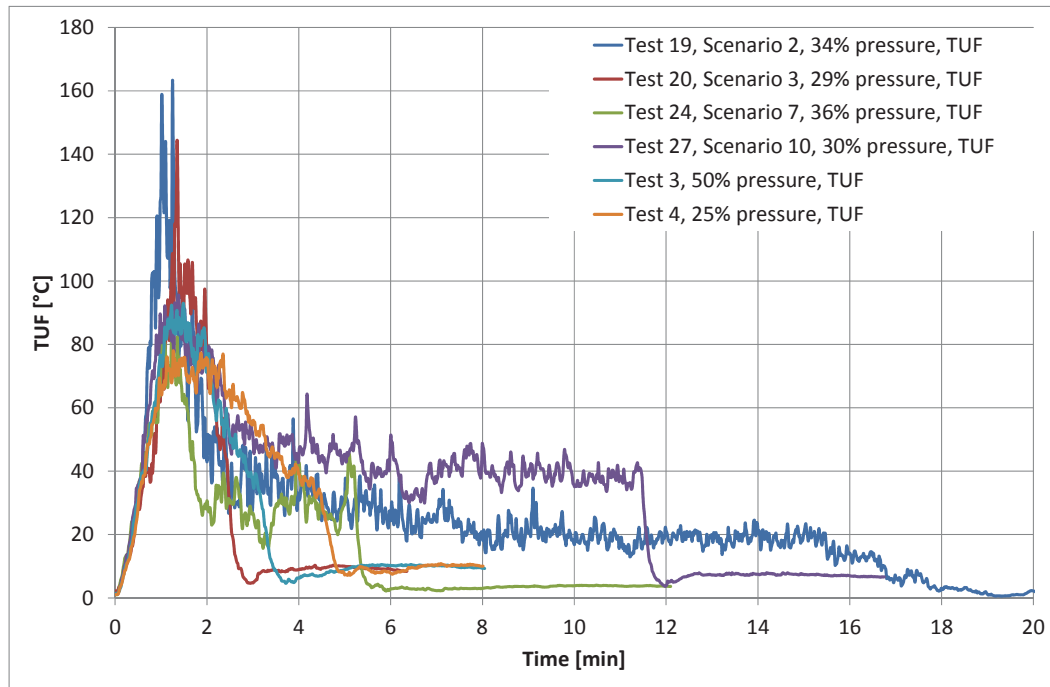
**Figure 28 - Temperature Uniformity Factors versus time for tests with damaged pipes and pressures between 25% and 50% of normal operating pressure. Damage scenarios (Tests 19, 20, 24 and 27) are compared with intact system with reduced pressure (Tests 3 and 4).**

Observations for damage scenario tests with 25% - 50% of normal operation pressure	
Gas temperatures	The water mist system with damaged piping reduced the compartment temperatures faster the system with intact piping and comparable system pressure. The initial peak temperature was higher in the tests with the damaged water mist system.
PT temperatures	The maximum average PT-temperature varied between 244°C and 283°C. No obvious difference between the performance of damaged systems and intact systems with comparable pressures was observed.
Extinguishment	Even though the system pressure in these damage scenarios only varied between 29 and 36 % of normal operating pressure, the time to extinguishment varied considerably. In Test 19 the fire was not extinguished before the fuel was consumed. In Test 20 the fire was extinguished 2:00 min after activation, in Test 24 4:50 min after activation and in Test 27 10:59 min after activation of the water mist system.

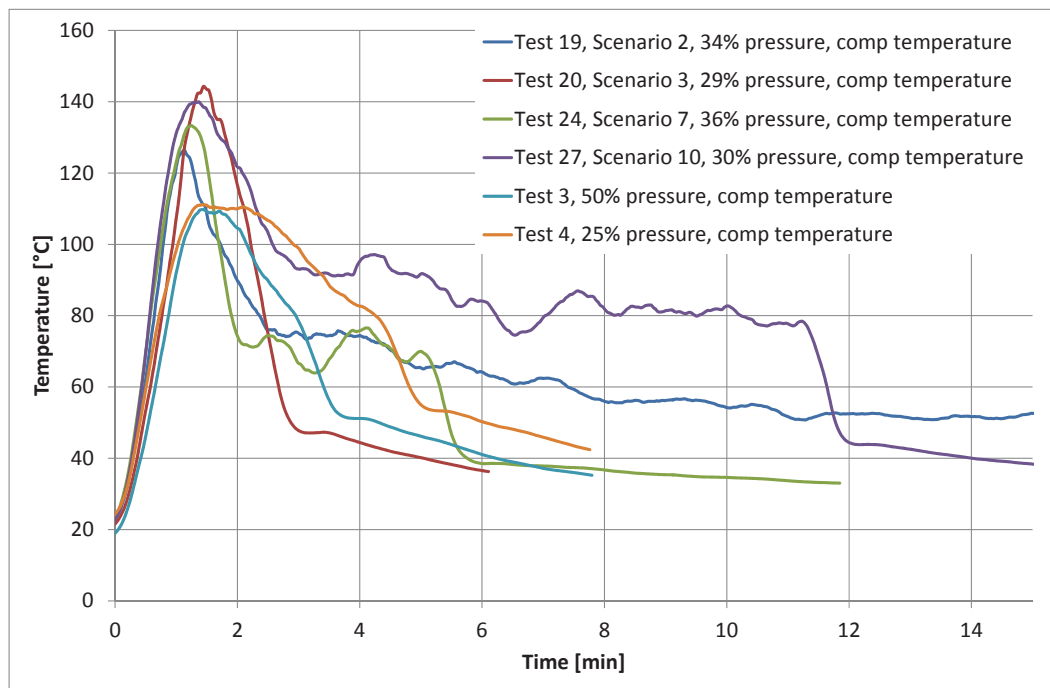
**Figure 29 - Average compartment temperatures versus time in tests with damaged pipes and pressures between 25% and 50% of normal operating pressure. Damage scenarios (Tests 19, 20, 24 and 27) are compared with intact system with reduced pressure (Tests 3 and 4).**

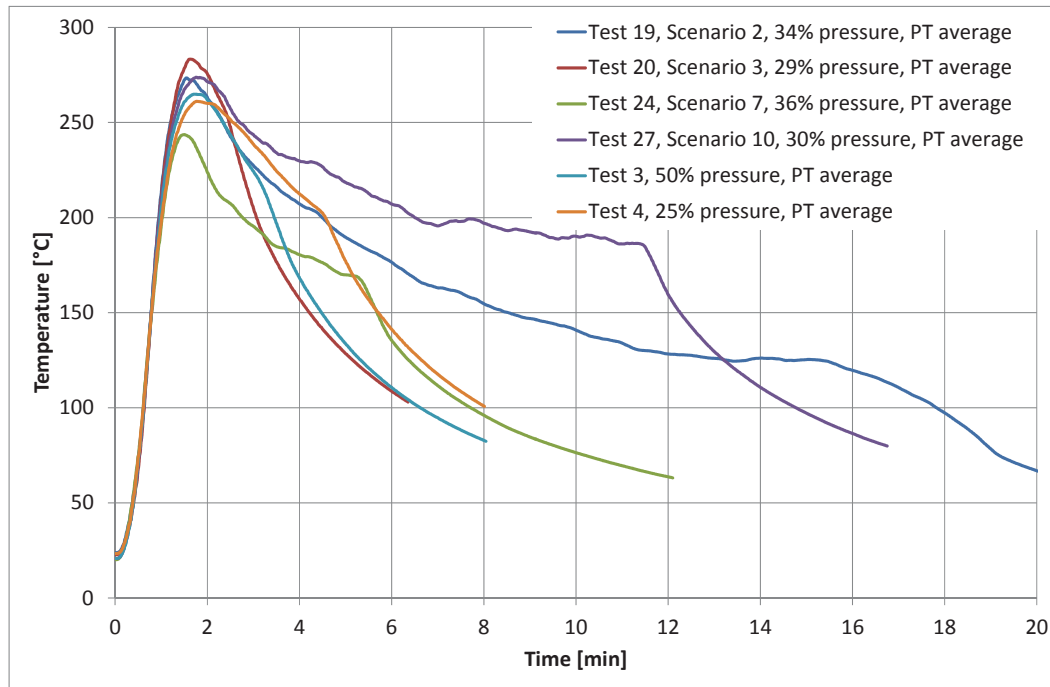
**Figure 30 - Average PT (plate thermometer) temperatures versus time for tests with damaged pipes and pressures between 25% and 50% of normal operating pressure. Damage scenarios (Tests 19, 20, 24 and 27) are compared with intact system with reduced pressure (Tests 3 and 4).**

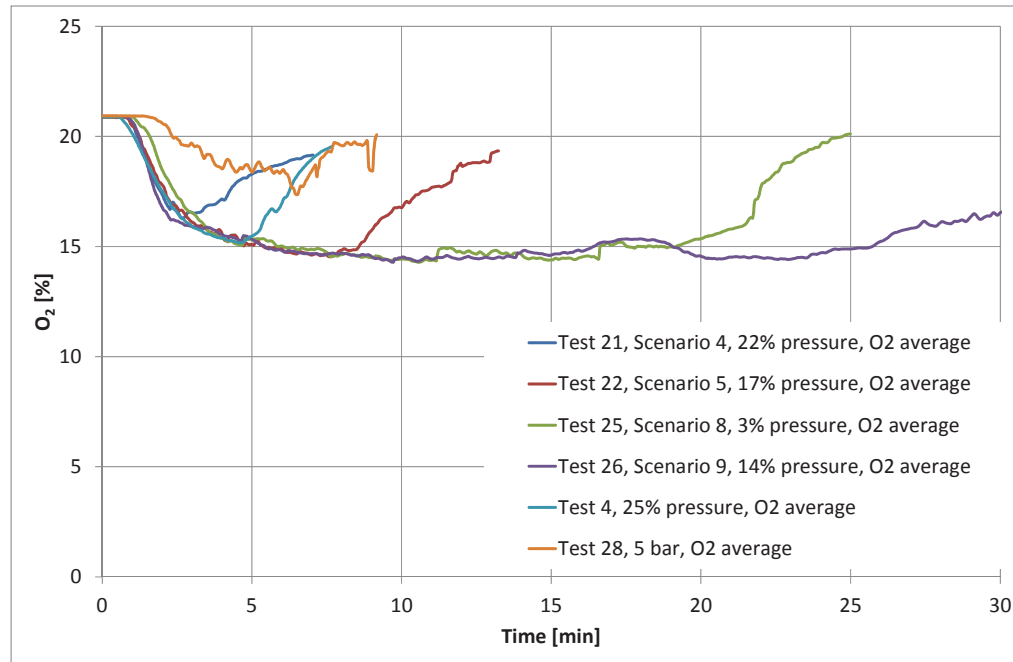
**Figure 31 - Average oxygen concentrations versus time for tests with damaged pipes and pressures between 0% and 25% of normal operating pressure. Damage scenarios (Tests 21, 22, 25 and 26) are compared with intact system with reduced pressure (Tests 4 and 28).**

Observations for damage scenario tests with 0% - 25% of normal operation pressure	
Gas temperatures	The damaged water mist system reduced compartment temperatures faster than was observed for the test with intact piping at 25% of normal operation pressure. The damaged water mist system used in Test 25 (3% of operating pressure) performed much better than the intact system at 5 bar. The testing indicated the system with a large puncture (16 x 6 mm, k-factor of 52) in one of the supply lines that resulted in an almost complete loss of pressure was capable of reducing gas temperatures from 500°C (free burning) to about 150°C - 170°C.
PT temperatures	The maximum average PT-temperature varied between 258°C and 309°C. The difference between the performance of damaged systems and intact systems with comparable pressures were small. In Test 25 (3% of normal operation pressure) the maximum average PT-temperature was 343°C and decreased slowly until the fuel was consumed.

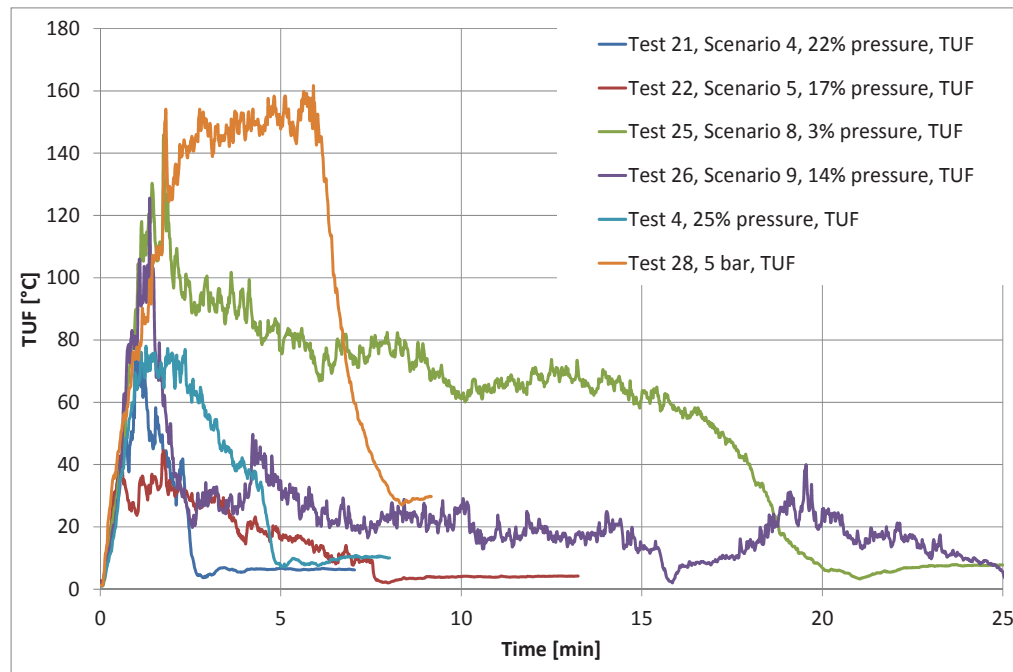
**Figure 32 - Temperature Uniformity Factors versus time for tests with damaged pipes and pressures between 0% and 25% of normal operating pressure. Damage scenarios (Tests 21, 22, 25 and 26) are compared with intact system with reduced pressure (Tests 4 and 28).**

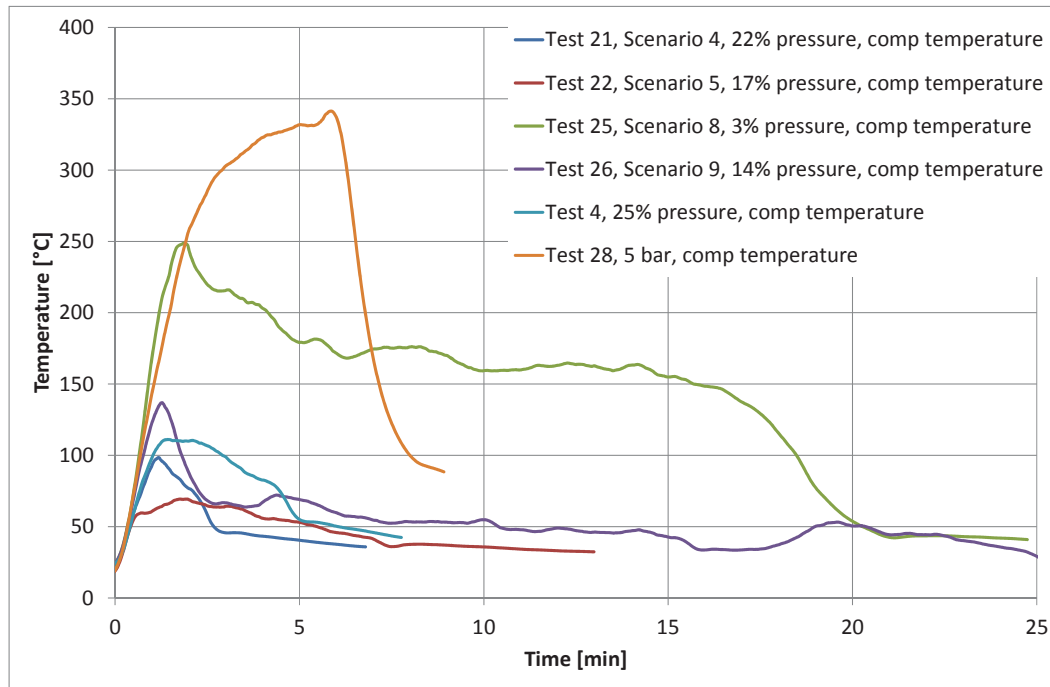
**Figure 33 - Average compartment temperatures versus time for tests with damaged pipes and pressures between 0% and 25% of normal operating pressure. Damage scenarios (Tests 21, 22, 25 and 26) are compared with intact system with reduced pressure (Tests 4 and 28).**

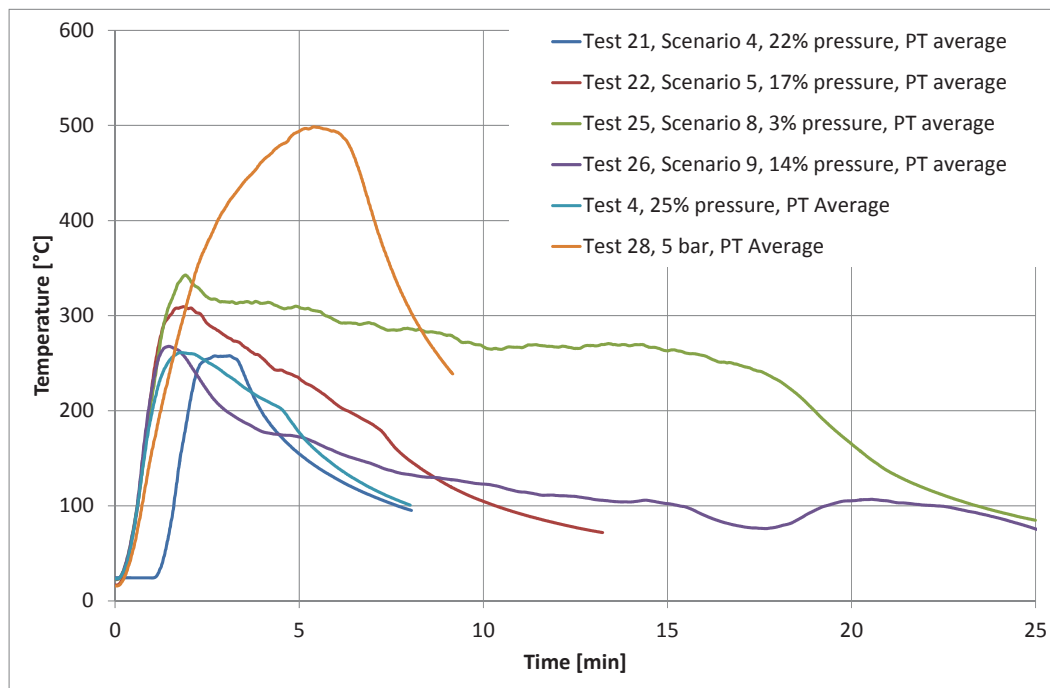
**Figure 34 - Average PT (plate thermometer) temperatures versus time for tests with damaged pipes and pressures between 0% and 25% of normal operating pressure. Damage scenarios (Tests 21, 22, 25 and 26) are compared with intact system with reduced pressure (Tests 4 and 28).**

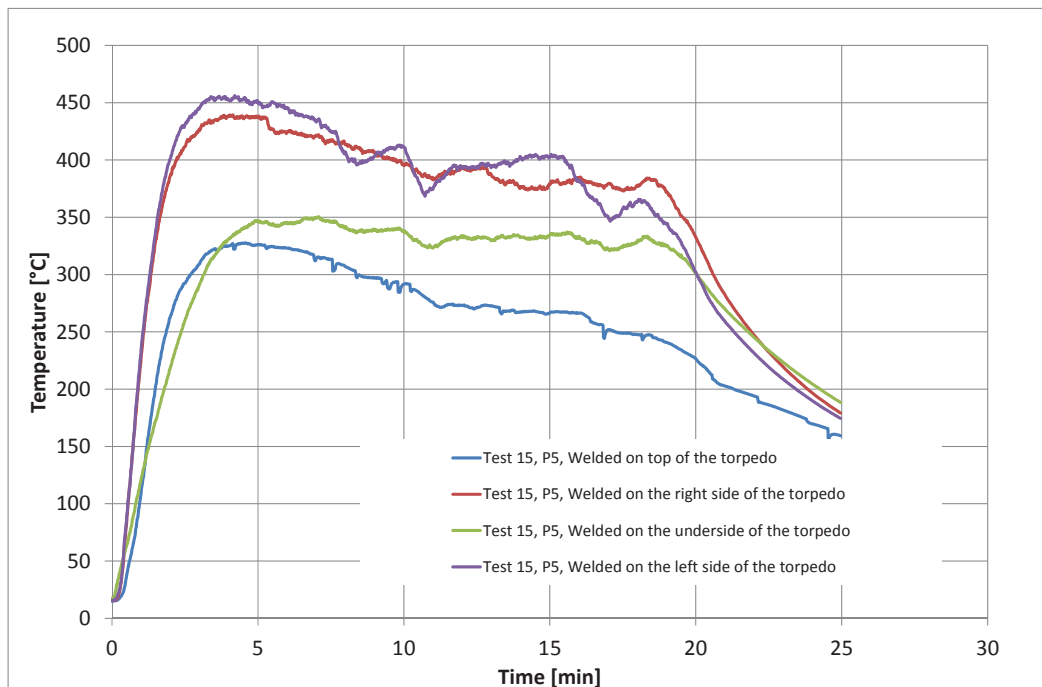
Figure 35 – Torpedo dummy temperatures versus time for Test 15 with fuel pan in position 1.

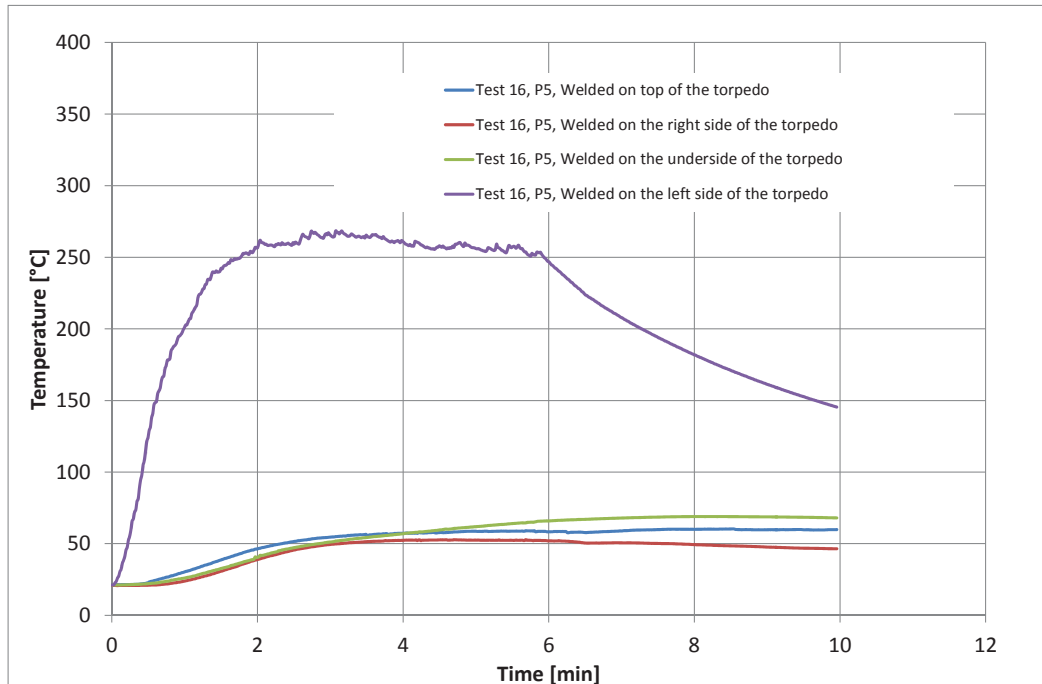
Figure 36 - Torpedo dummy temperatures versus time for Test 16 with fuel pan in position 2.

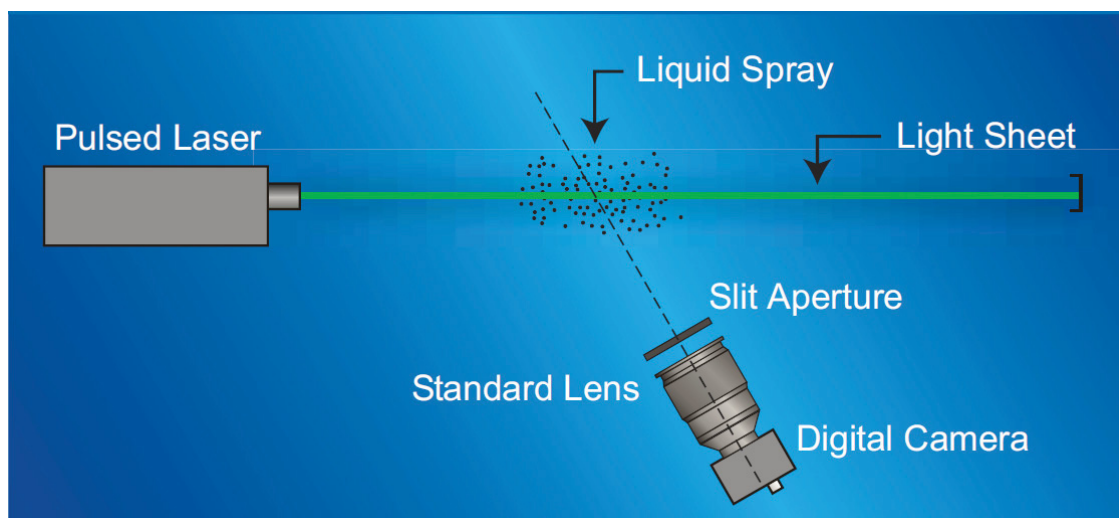
**Figure 37 Schematic of the Global Sizing Velocimetry apparatus [4].**

Figure 37 shows a schematic overview of the experimental setup for drop sizing using GSV.

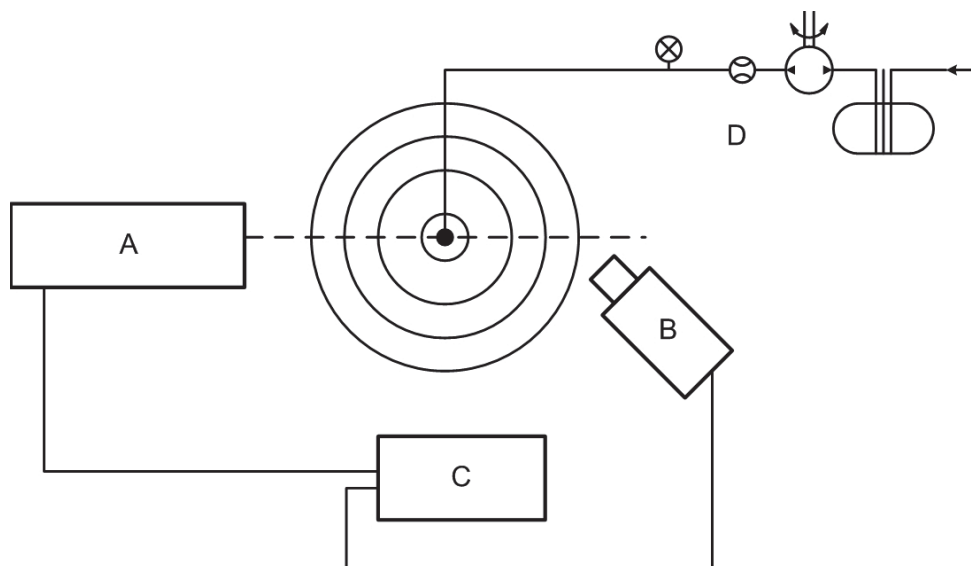
**Figure 38: Schematic of the experimental set-up. A: laser and beam expanding optics, B: camera and acquiring optics, C: control unit, D: hydraulics and control systems for the water mist system.**

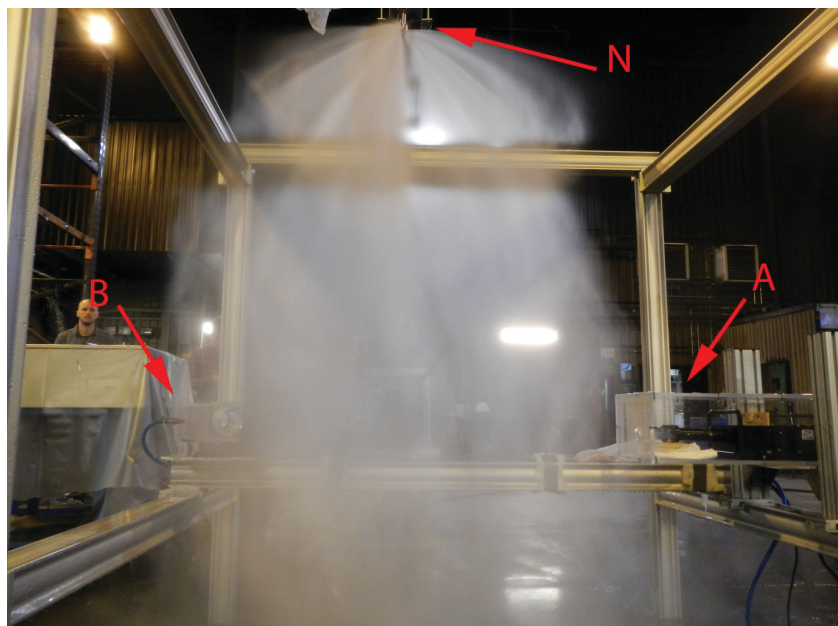
**Figure 39: Photograph of the experimental set-up depicting some of the employed equipment and components. A: laser and beam expanding optics, B: camera and acquiring optics, N: nozzle.**

For illustrative purposes, Figure 39 and Figure 40 show a photograph of the experimental setup and a photograph captured at the instant when measurements were being made respectively.

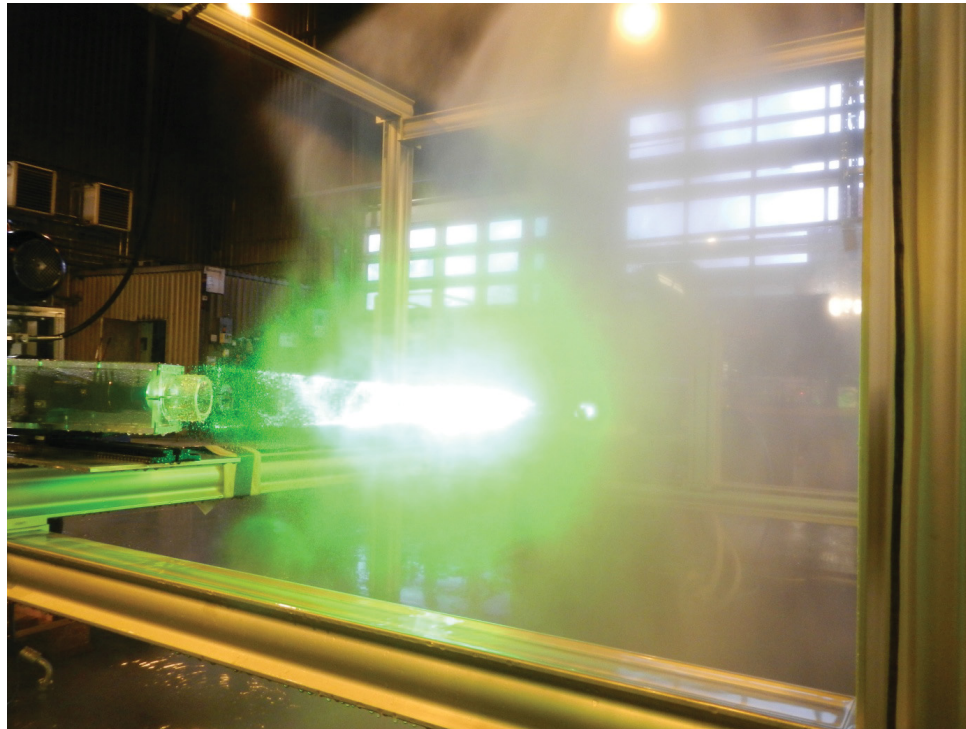
**Figure 40:** Photograph captured at the instant when measurements were being conducted. The photograph shows a laser pulse being fired through the spray and the front of the camera and its collecting optics.

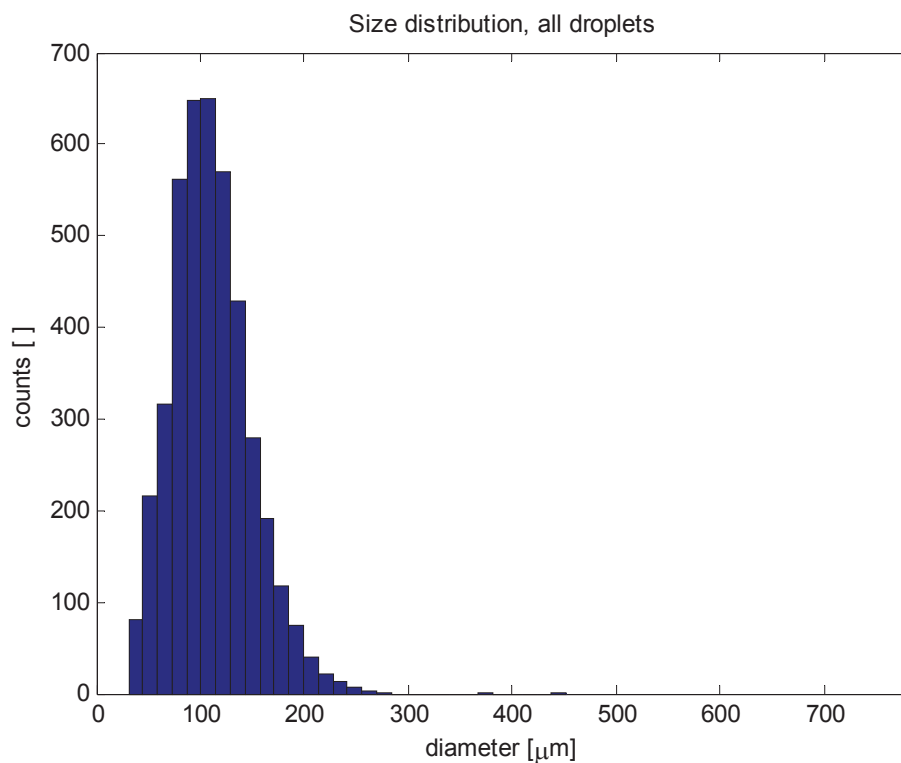
Figure 41. Size distribution in spray/plume, injection pressure 100 bar.

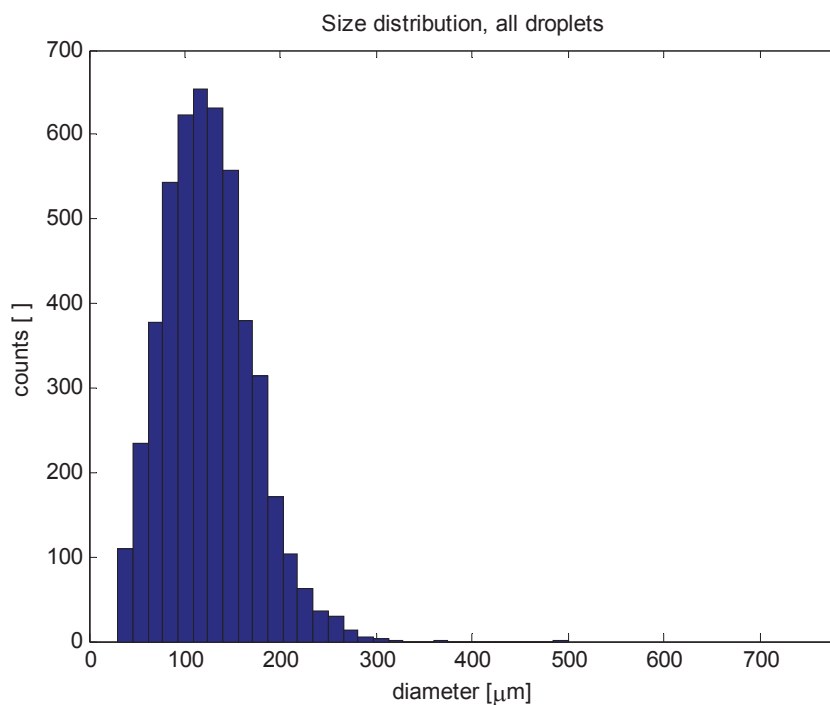
Figure 42. Size distribution in spray/plume, injection pressure 75 bar.

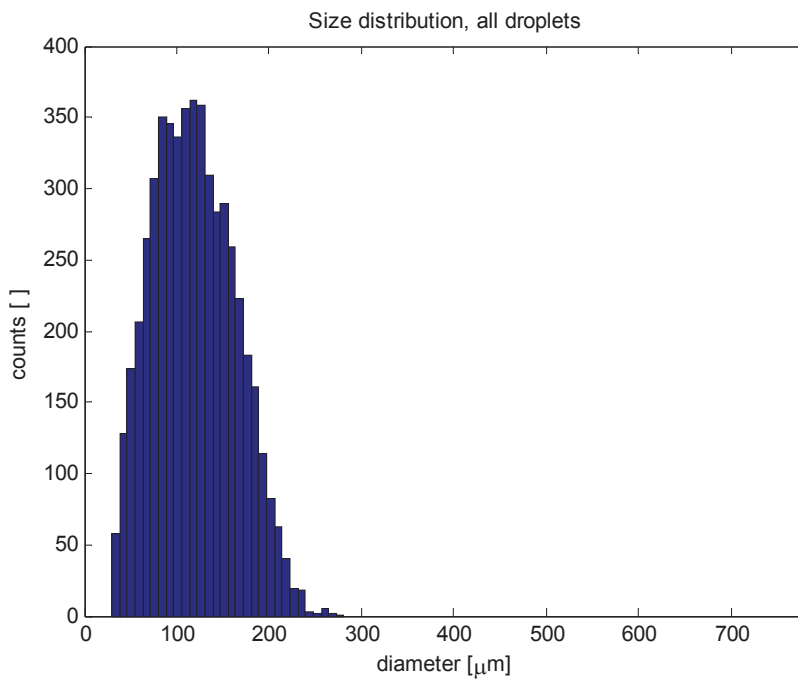
Figure 43. Size distribution in spray/plume, injection pressure 50 bar.

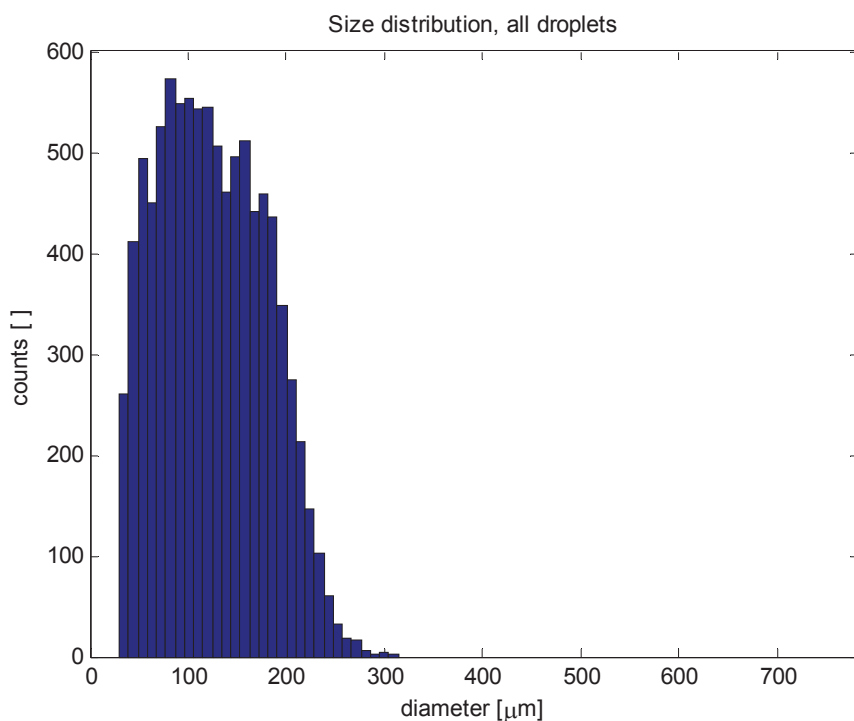
Figure 44. Size distribution in spray/plume, injection pressure 25 bar.

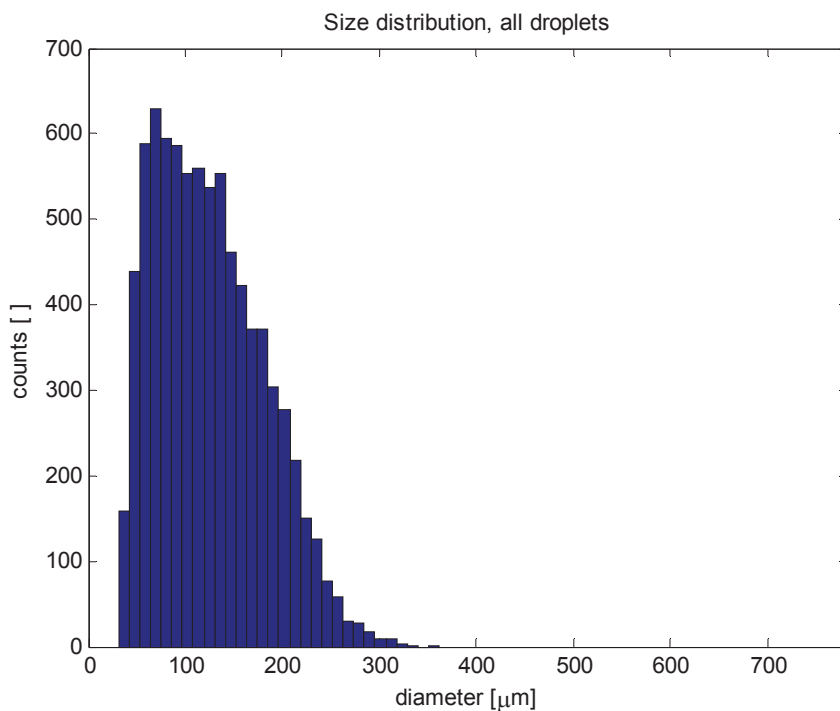
Figure 45. Size distribution in spray/plume, injection pressure 12 bar.

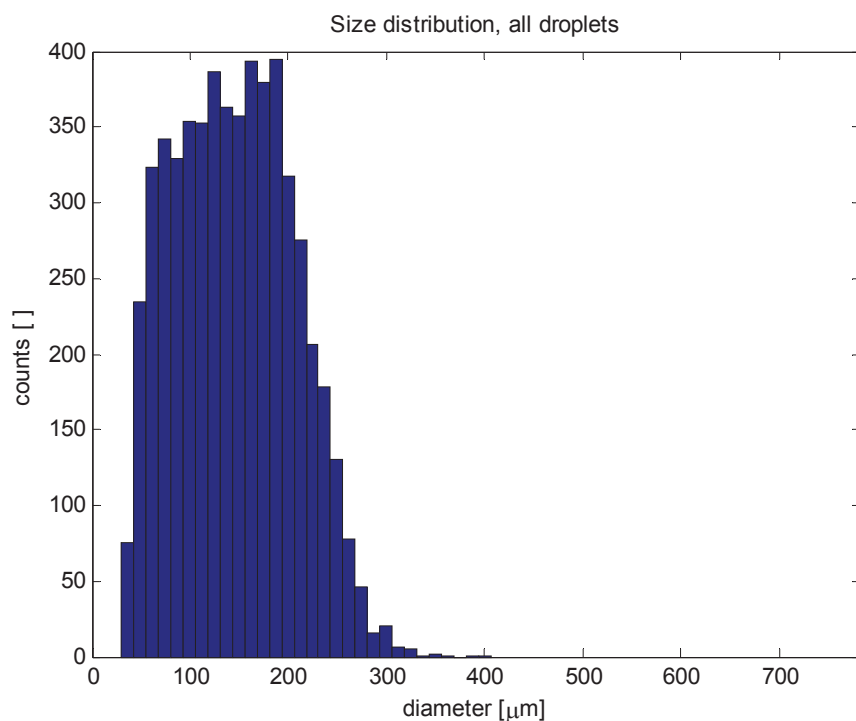
Figure 46. Size distribution in spray/plume, injection pressure 6 bar.

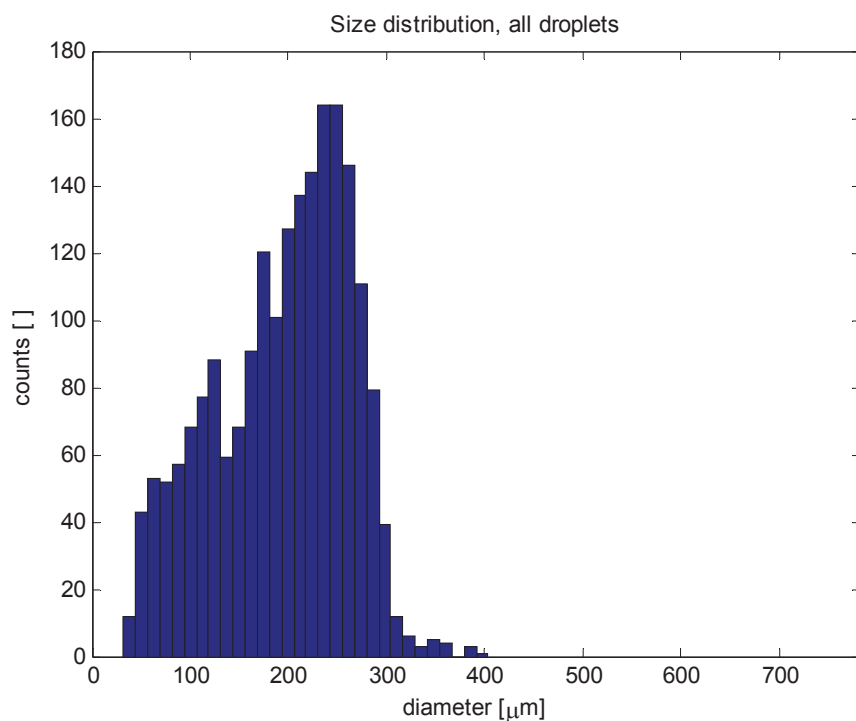
Figure 47. Size distribution in spray/plume, injection pressure 3 bar.

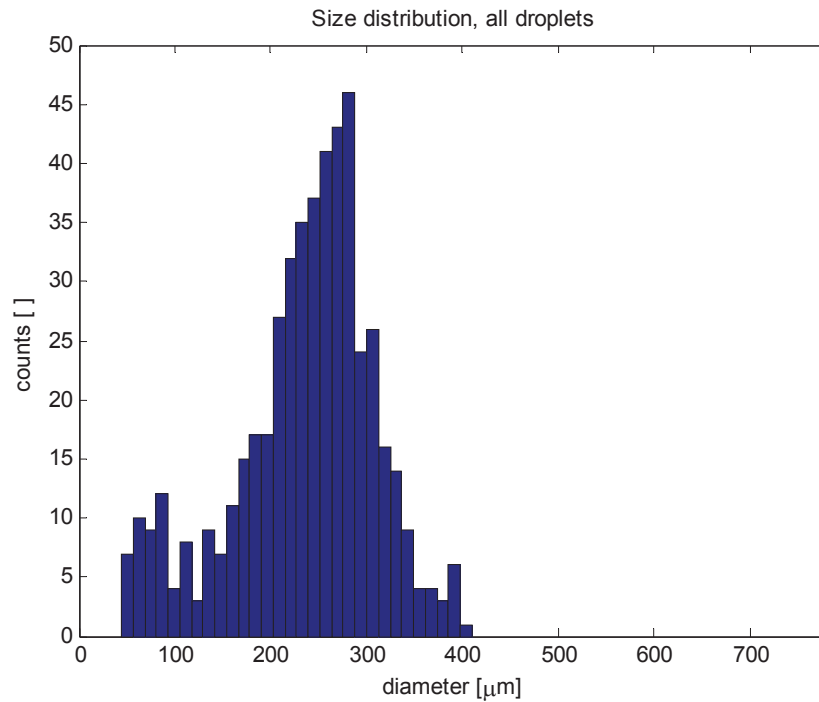
Figure 48. Size distribution in spray/plume, injection pressure 1.5 bar.

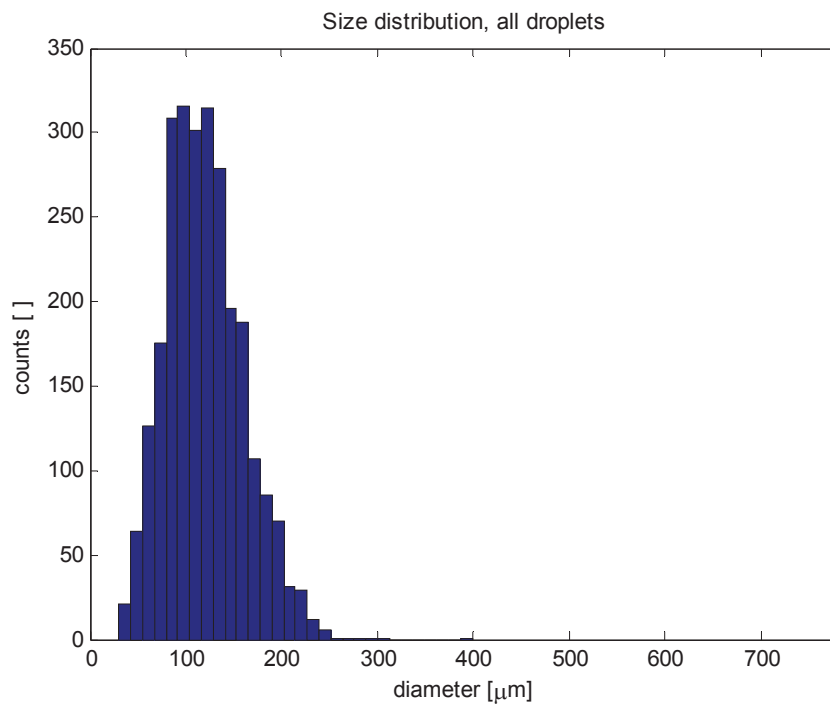
Figure 49. Size distribution between sprays/plumes, injection pressure 100 bar.

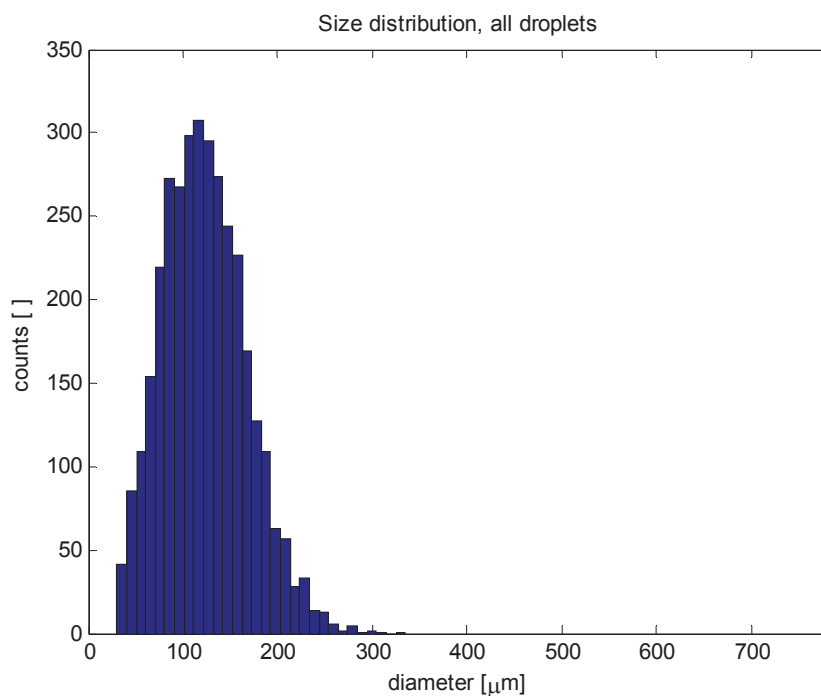
Figure 50. Size distribution between sprays/plumes, injection pressure 75 bar.

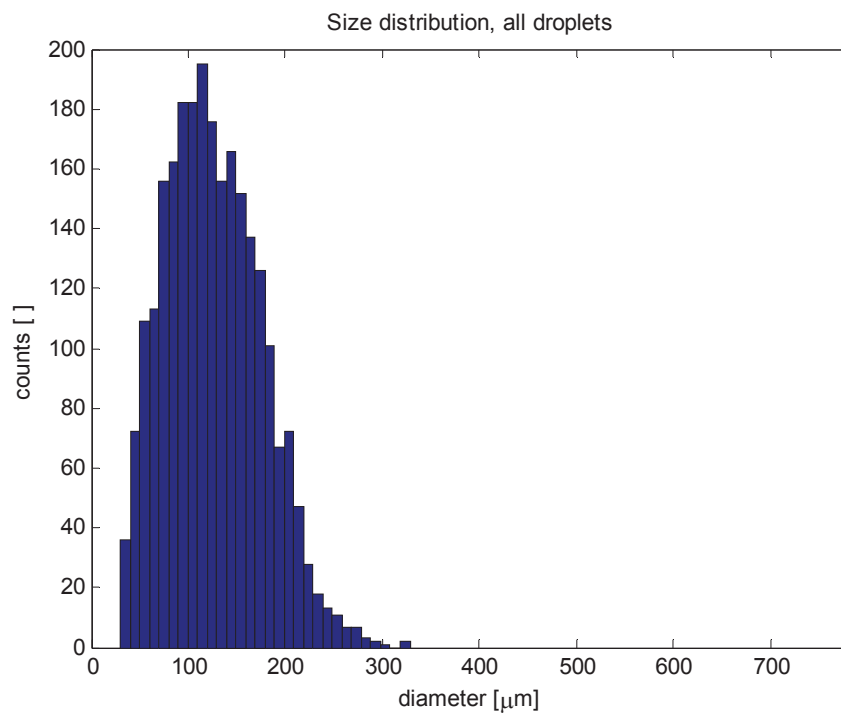
Figure 51. Size distribution between sprays/plumes, injection pressure 50 bar.

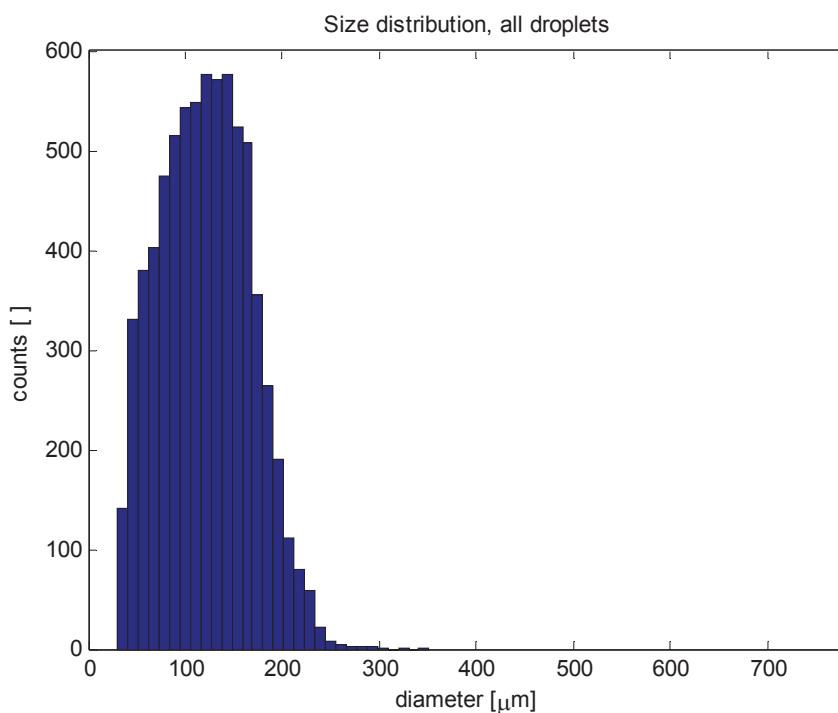
Figure 52. Size distribution between sprays/plumes, injection pressure 25 bar.

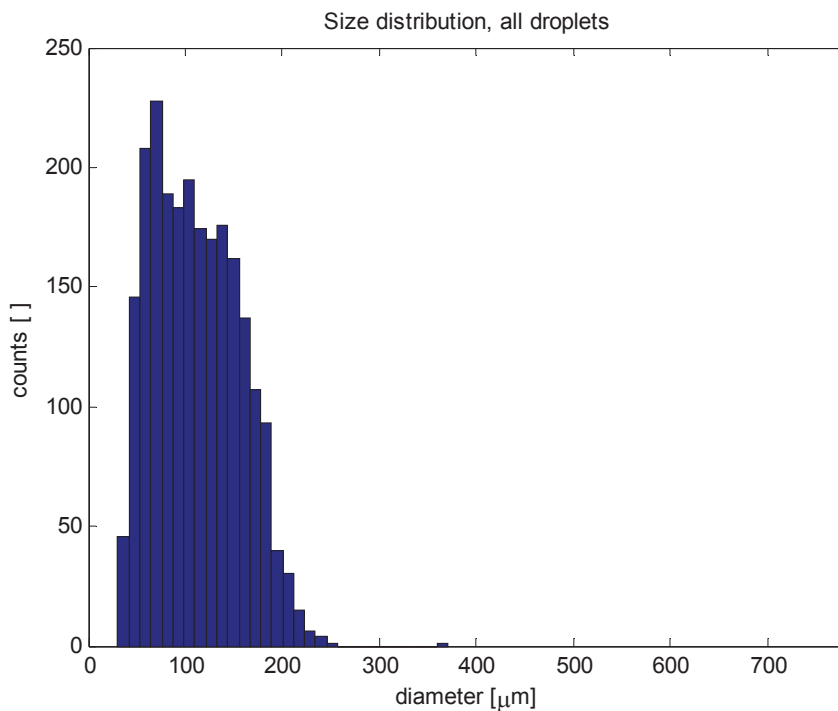
Figure 53. Size distribution between sprays/plumes, injection pressure 12 bar.

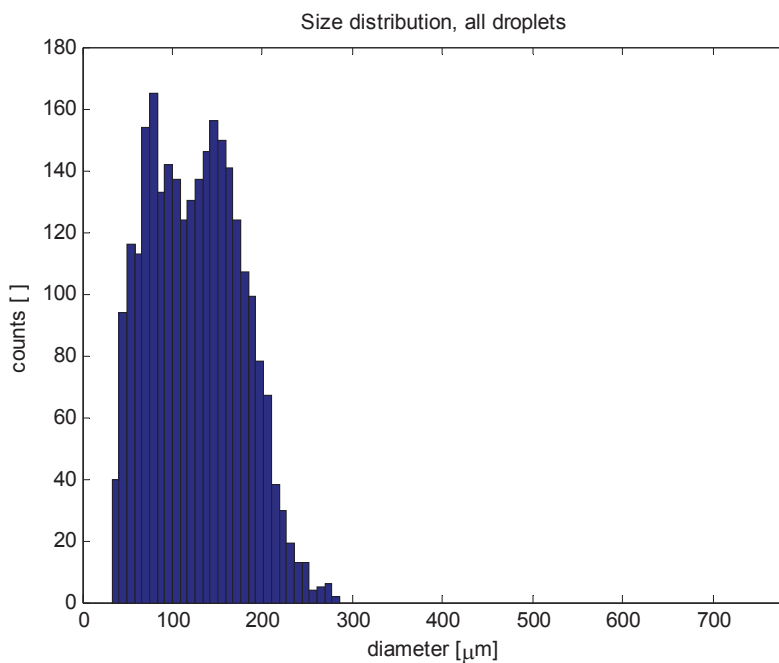
Figure 54. Size distribution between sprays/plumes, injection pressure 6 bar.

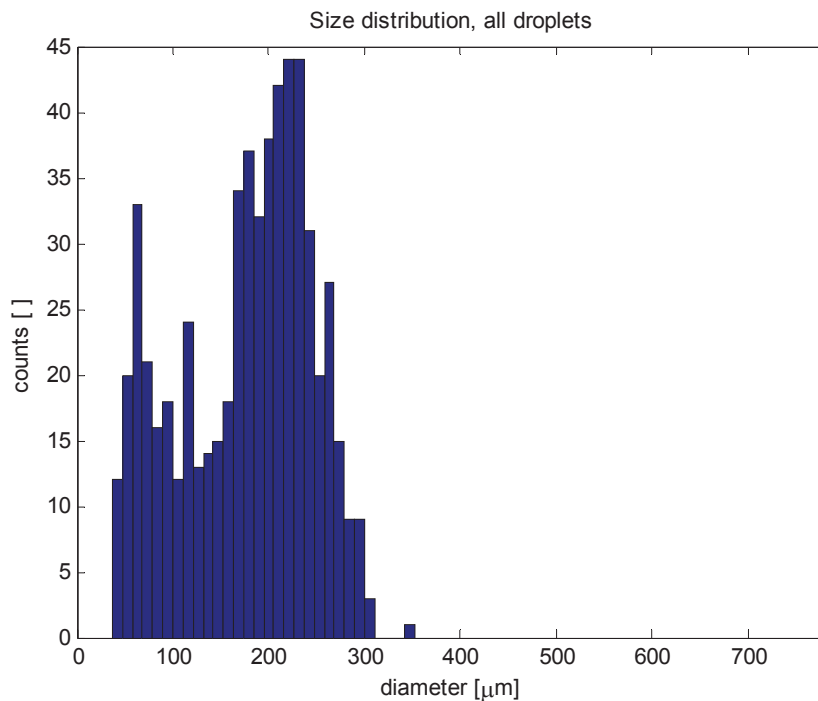
Figure 55. Size distribution between sprays/plumes, injection pressure 3 bar.

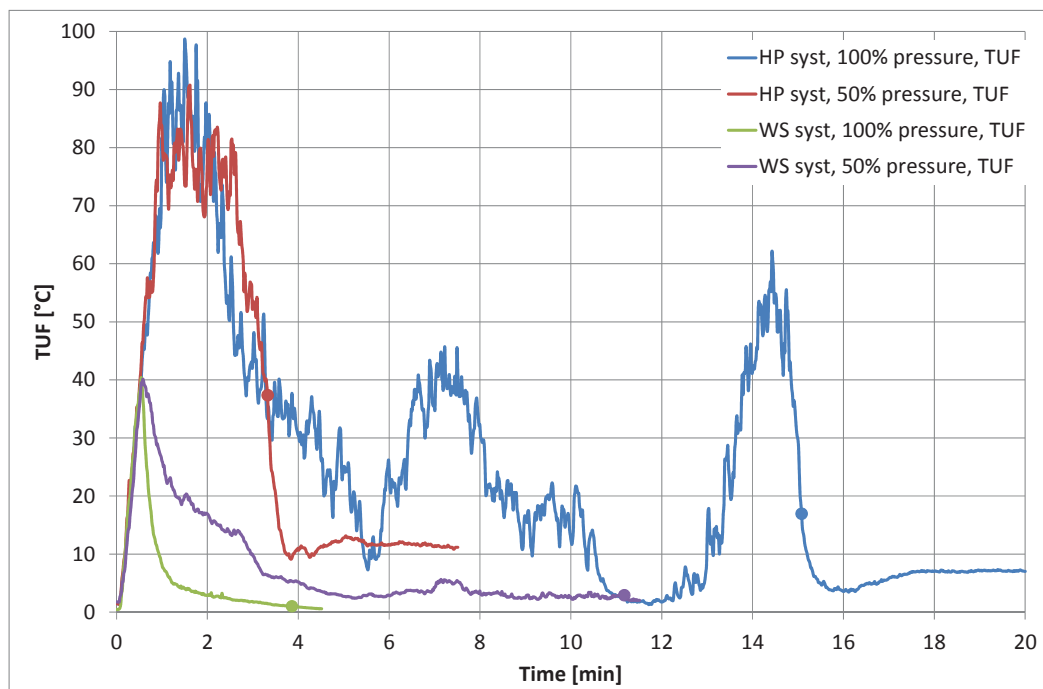
**Figure 56 – Comparison of variation of TUFs with time of the high pressure (HP) water mist system in this test series and a water spray (WS) system. The time of extinguishment is marked with a dot.**

In some of the tests using ‘damaged systems’, the damaged water mist system was quite efficient in mixing the gases in the compartment. This was seen in Tests 18, 21, 22 and 23. This could be an effect of asymmetry in the water discharge resulting from the punctures in the piping system creating turbulence in the compartment or simply an effect of the increased water discharge density in certain areas of the test space. Since the tests using a damaged system are a bit “uncontrolled” with regards to the direction of the spray from the punctures in the damaged pipes, the water might have in some cases (possibly in Tests 22 and 23, but not in Tests 18 and 21) hit the thermocouples directly and affected the calculated TUF values.

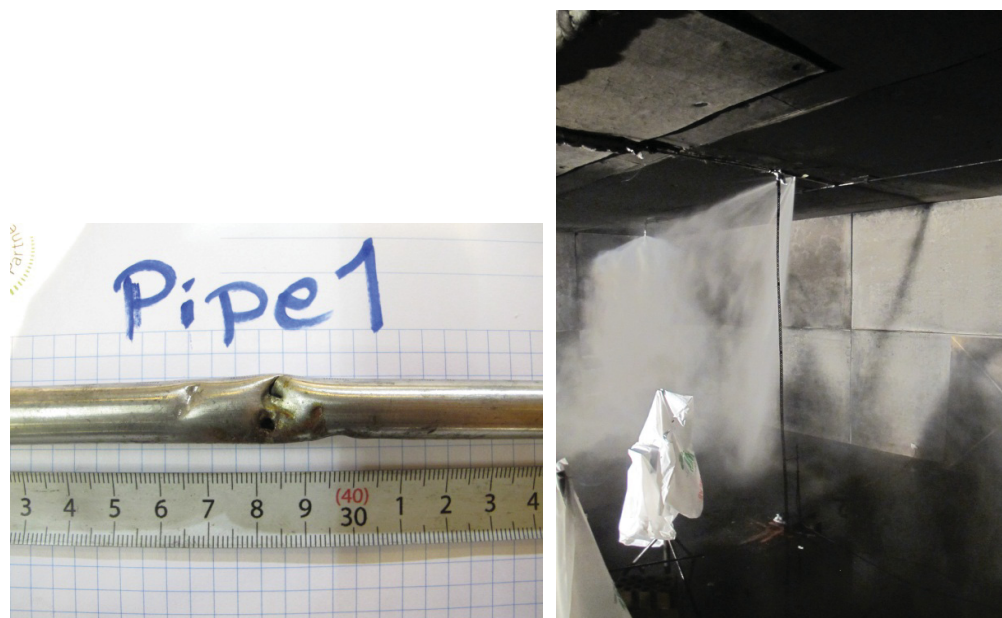
**Figure 57. Picture of pipe 1. In the left picture we see one puncture (approx. 2 mm) and one gash (approx. 6 mm). To the right is a picture of the spray from the puncture and gash when the pipe is installed in the test compartment. The pipe diameter is 12 mm.**

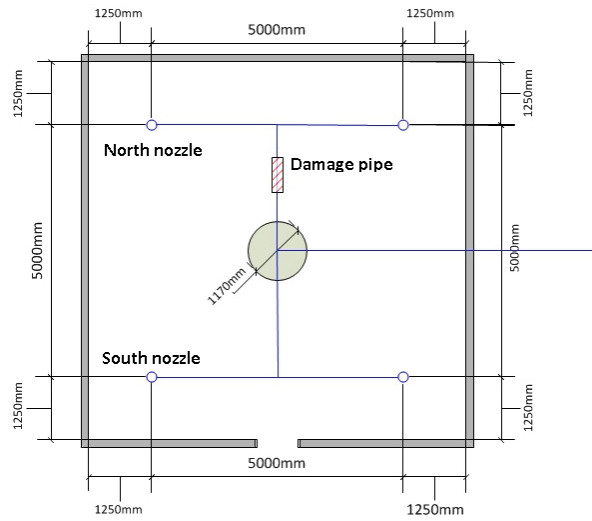
**Figure 58. Overview of test compartment and placement of damaged pipes in tests 1-6.**

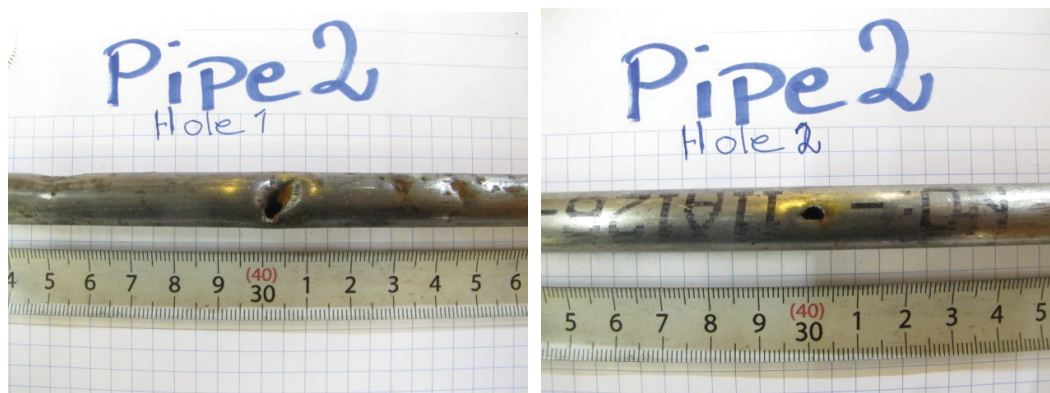
Figure 59. Picture of pipe 2. The pipe is punctured in two places, hole 1 (approx. 3×4 mm) to the left and hole 2 (approx. 4×2 mm) to the right. The pipe diameter is 12 mm.

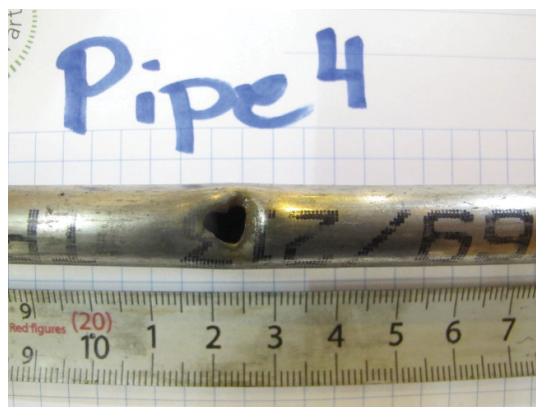
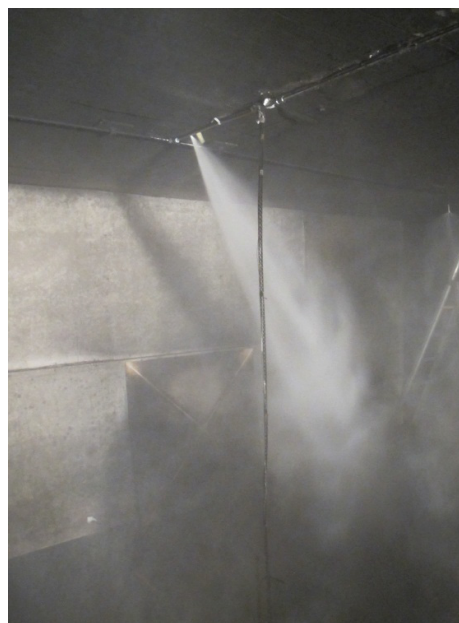
Figure 61. Picture of pipe 4, puncture is approx. 5×6 mm. To the right is a picture of the spray from the punctures when the pipe is installed in the test compartment. The pipe diameter is 12 mm.

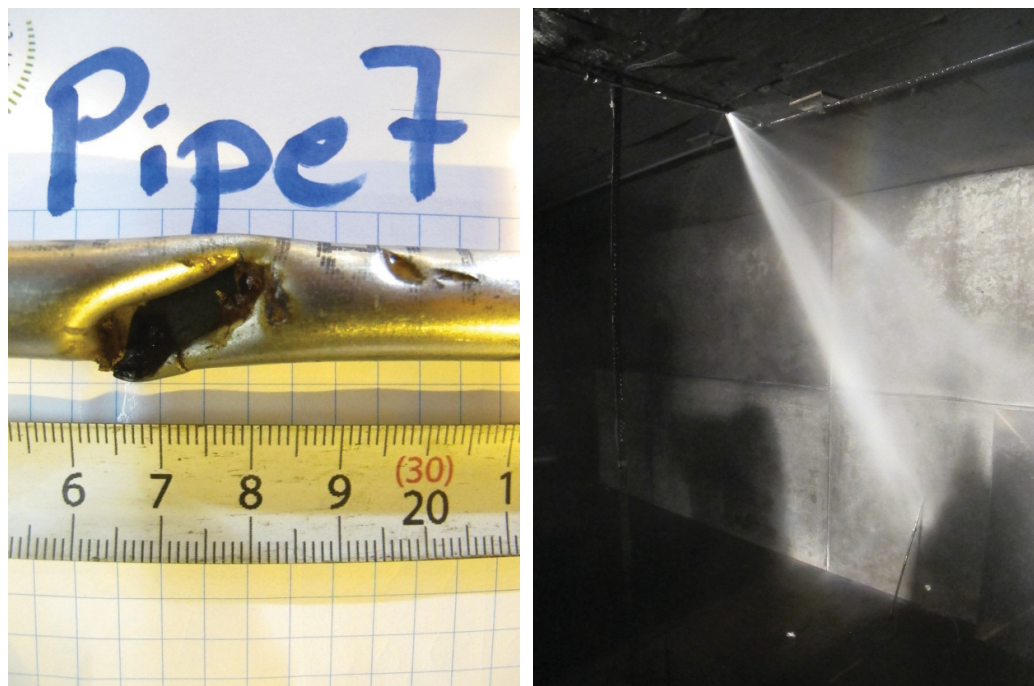
Figure 62. Picture of pipe 7, puncture approx. 16×12 mm. To the right is a picture of the spray from the punctures when the pipe is installed in the test compartment. The pipe diameter is 12 mm
